National Mission for Clean Ganga (NMCG)
Ministry of Jal Shakti,
River Development & Ganga Rejuvenation
Government of India

Development and Rehabilitation of Sewage Treatment Plants and Associated Infrastructure Under Hybrid Annuity Based PPP Mode at Prayagraj, Uttar Pradesh

Monthly Progress Report
of
Project Engineer
June 2022

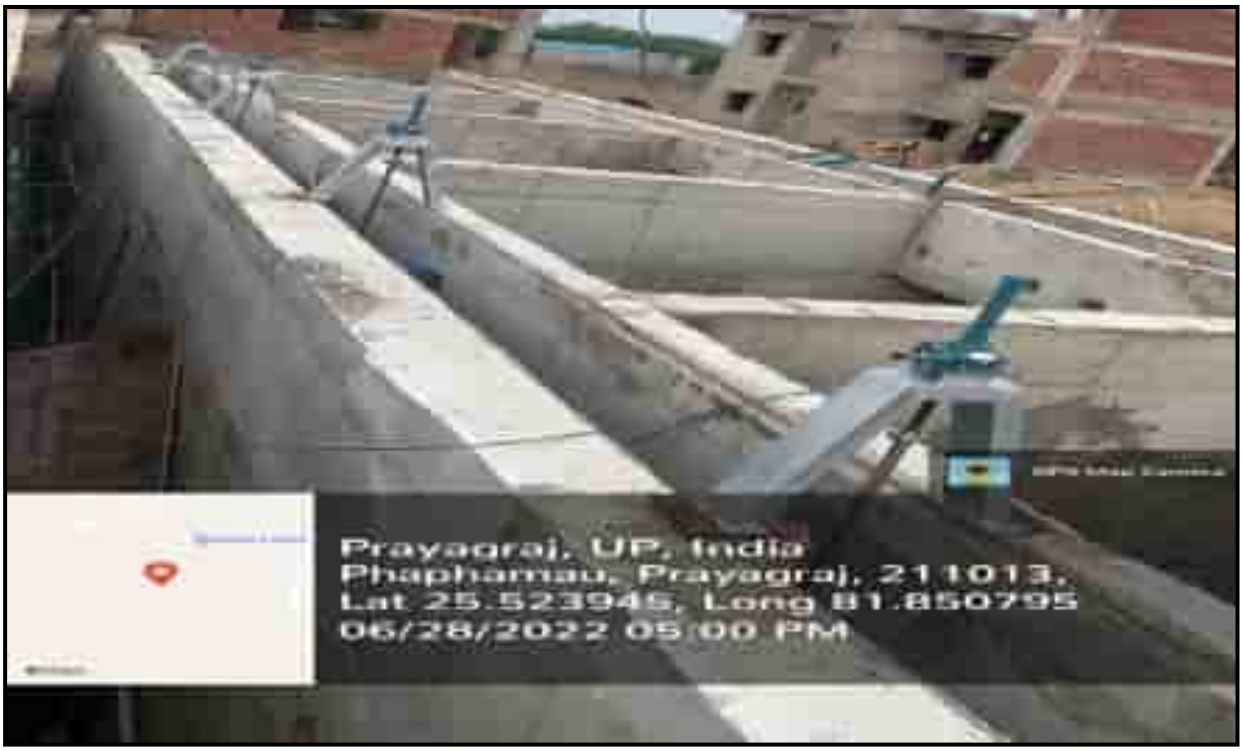
PHAPHAMAU FACILITY

FCR (STP): Basket Erection work under progress for FCR module

Tube Settler (STP) – Casting work completed

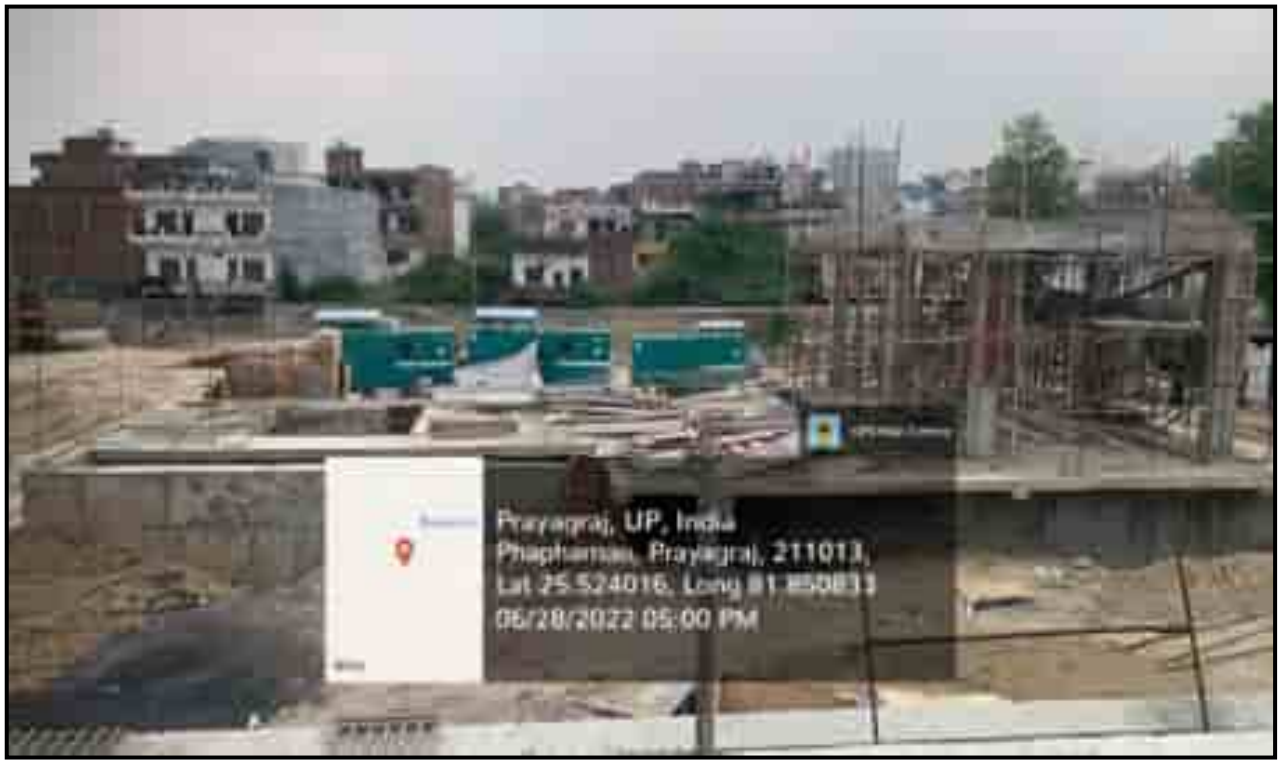
PHAPHAMAU FACILITY

Process Building (STP) – Column casting work under progress

MPS – Reinforcement and shuttering work under progress

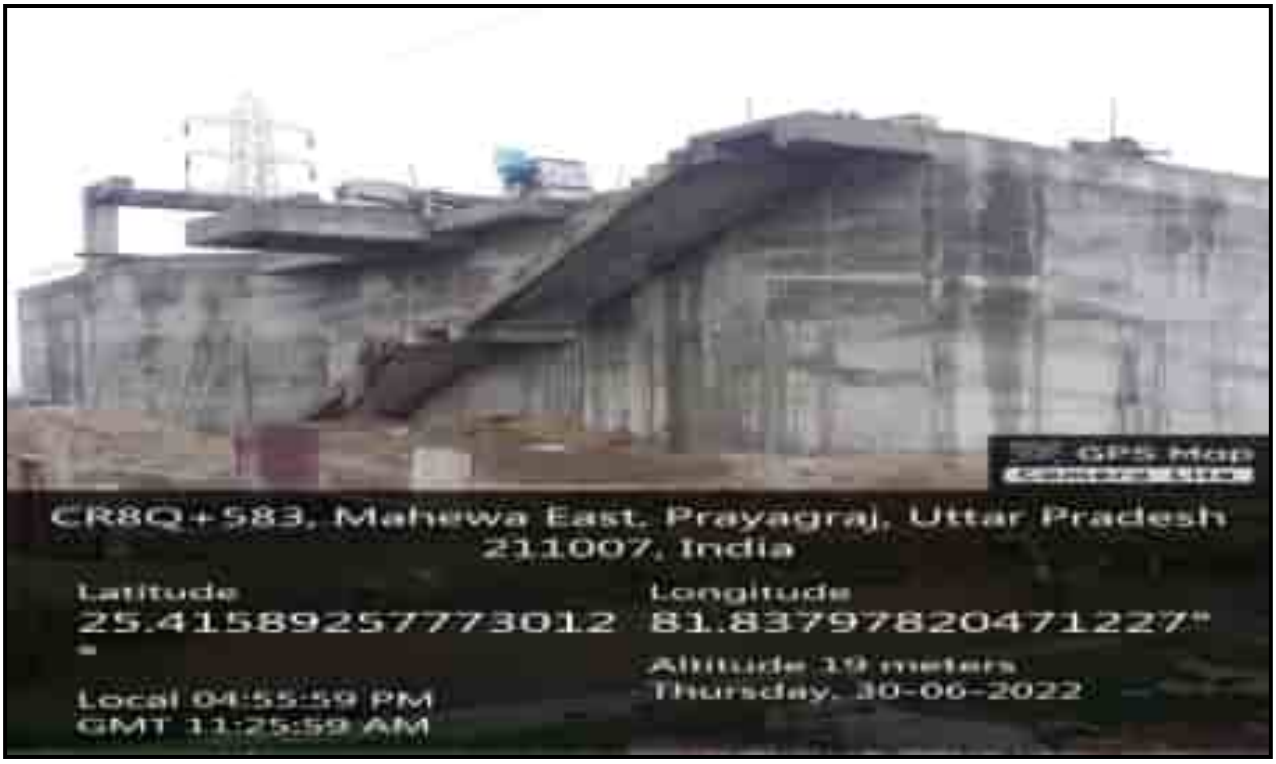
NAINI-II FACILITY

Mahewaghat SPS – Civil finishing work under progress

Mahewaghat SPS (Panel Room) – 2nd Slab De Shuttering work under progress

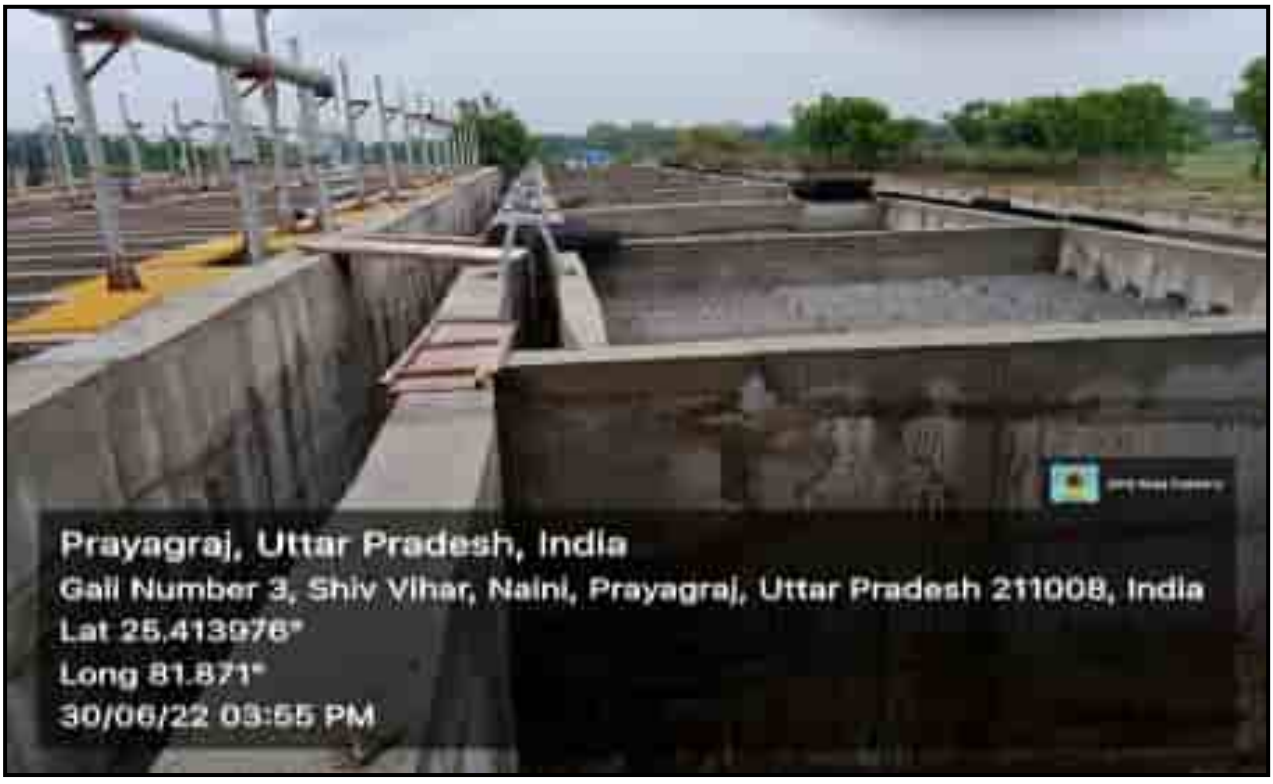
NAINI-II FACILITY

FCR – E&M work under progress

Tube settler – SS launder erection work under progress

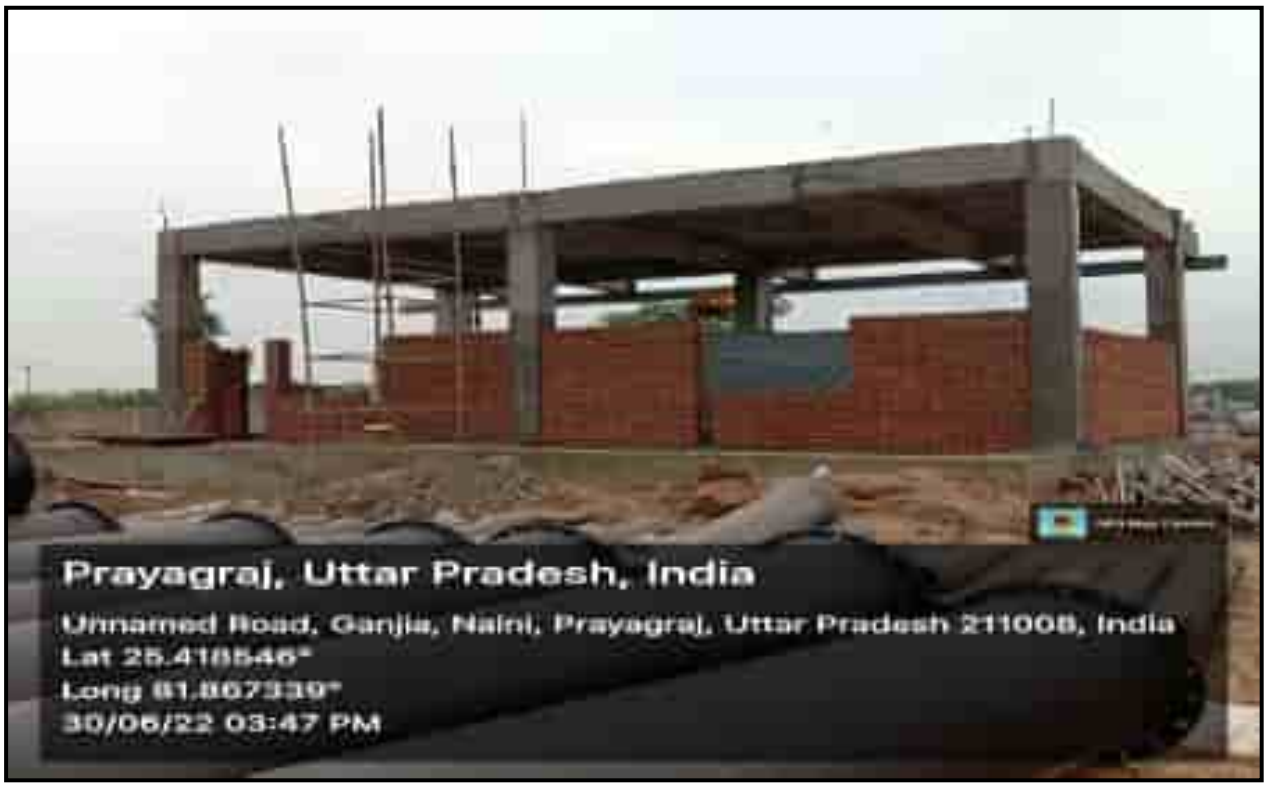
NAINI-II FACILITY

Naini-II MPS (Panel room)– Brick work under progress

2nd Staff Quarter (STP) – Construction work started

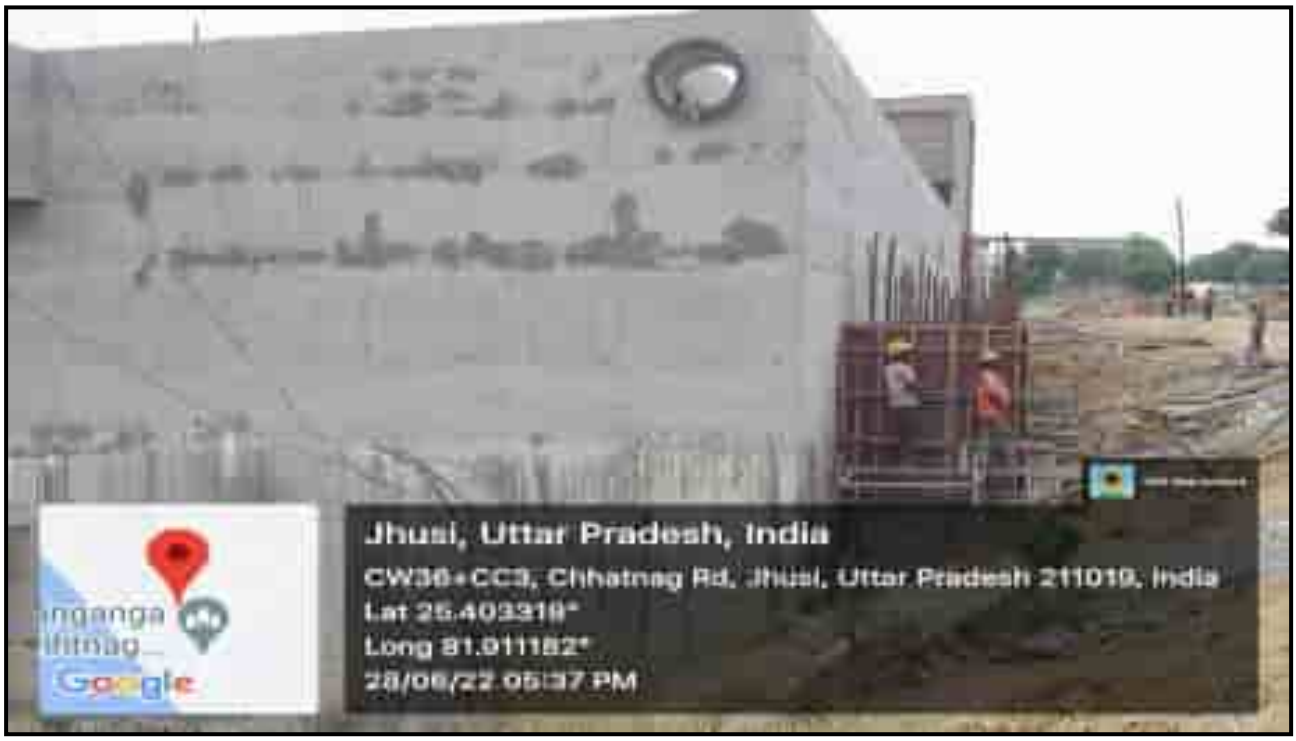
JHUNSI FACILITY

FCR – FCR module basket erection work completed

Tube settler – Civil finishing work completed

Staff Quarter – Painting work under progress
